Industrial Validations

Casting Model Validations

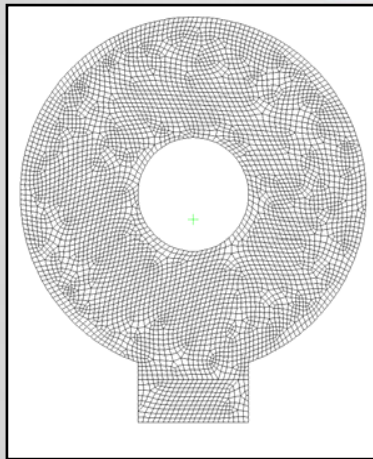
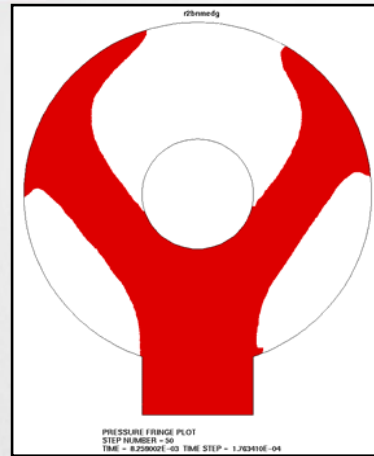
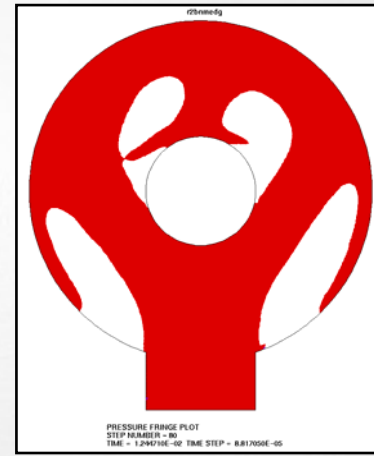
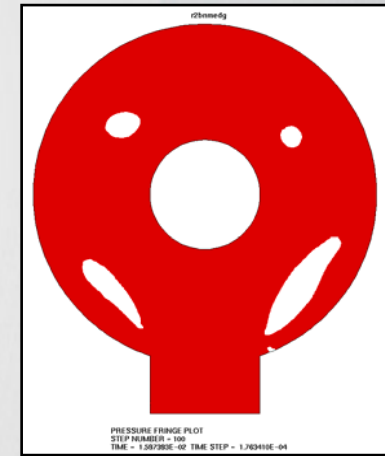
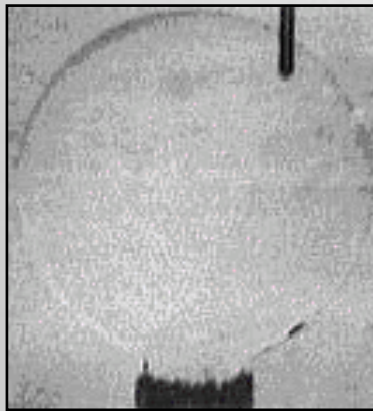
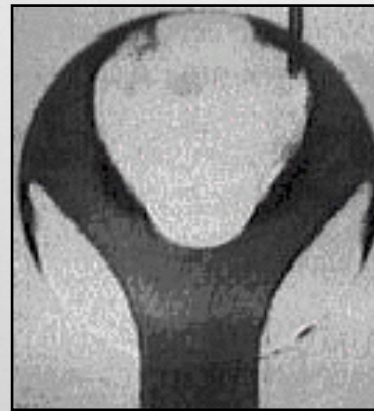
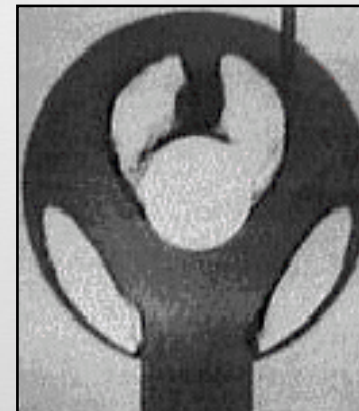
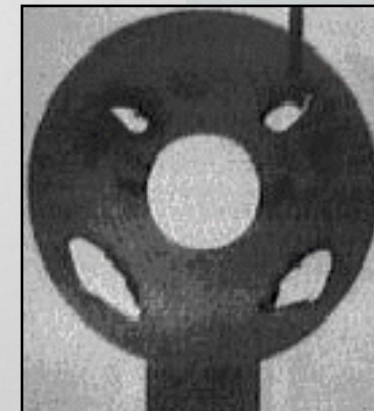
Filling (*Procast*)

Flow validation

Arbeitsgemeinschaft, Metallguss, Aalen (D)

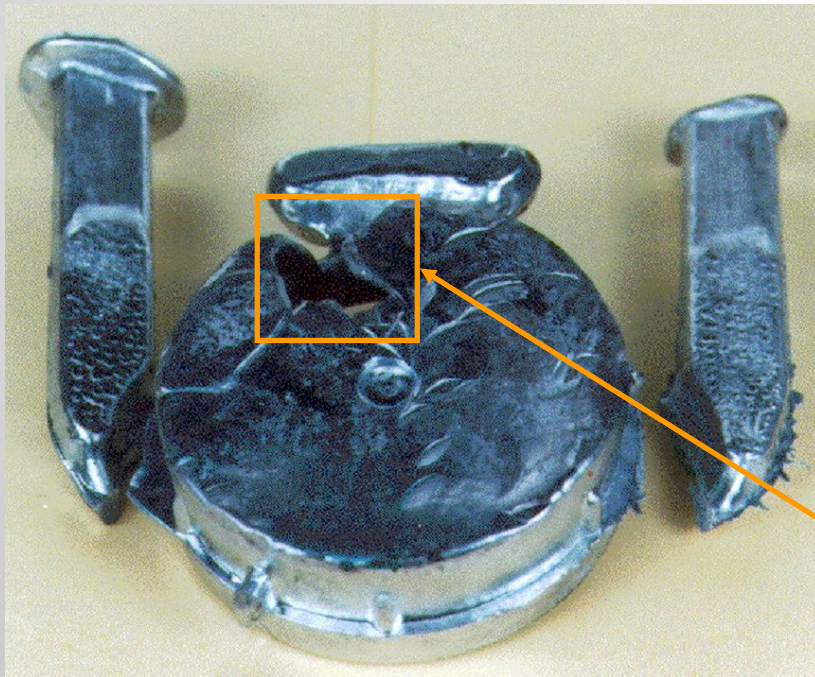
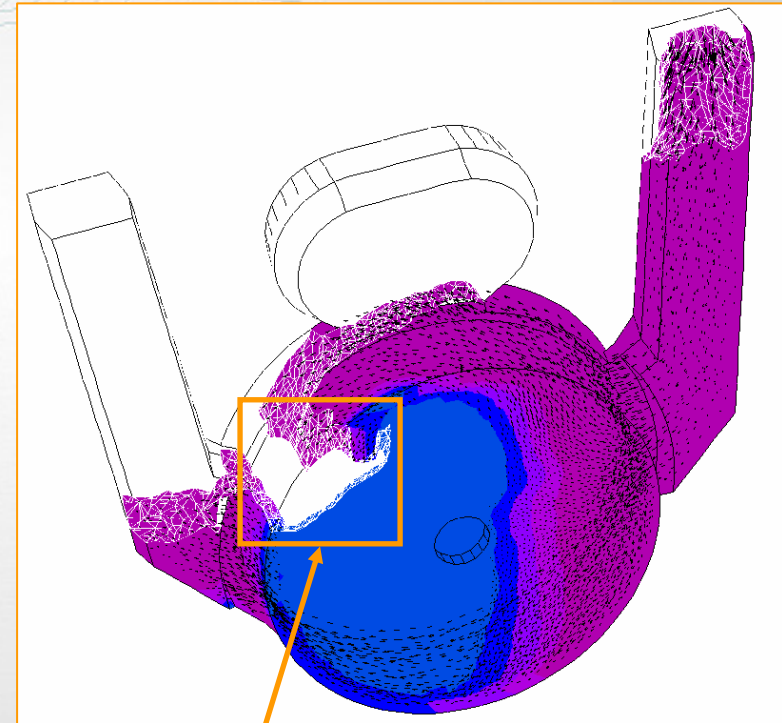
Filling (*Procast*)

Incomplete filling

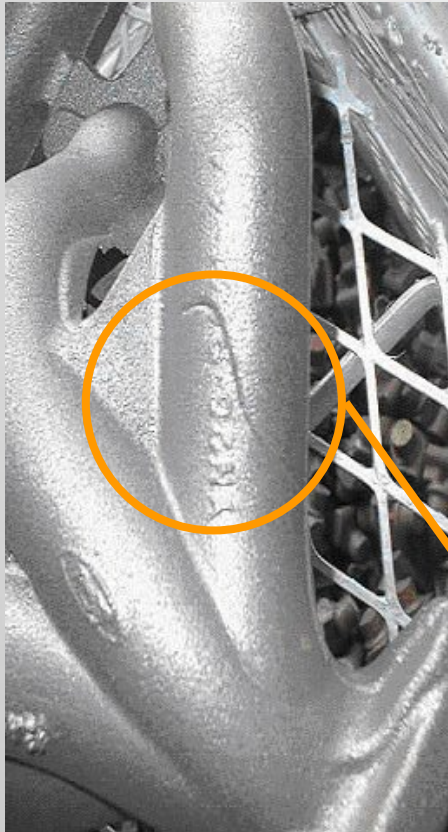
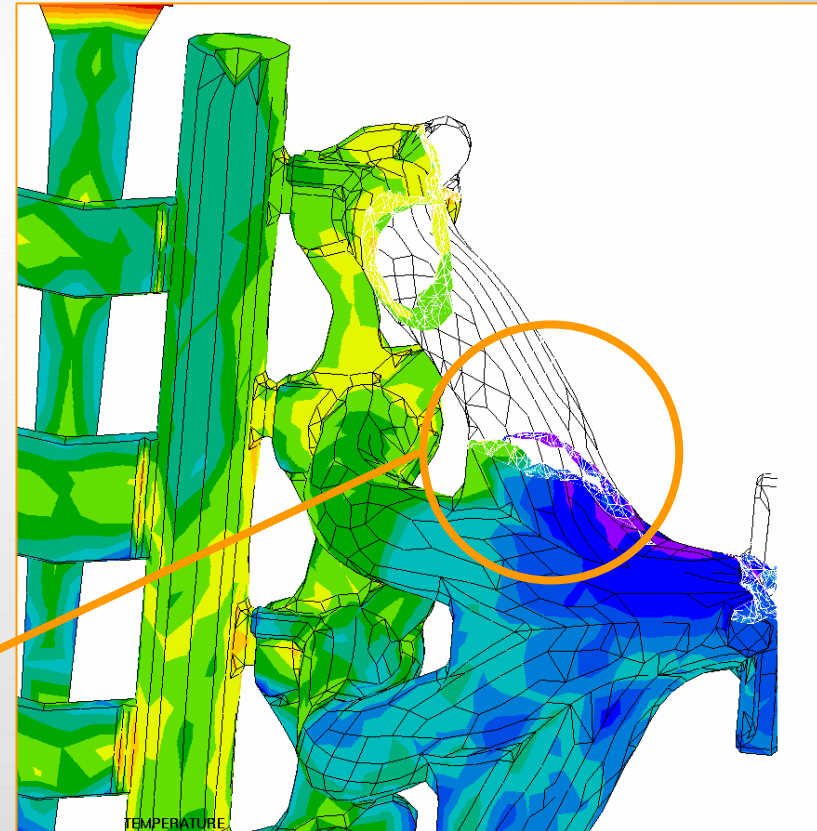
Filling (*Procast*)

Cold Shut

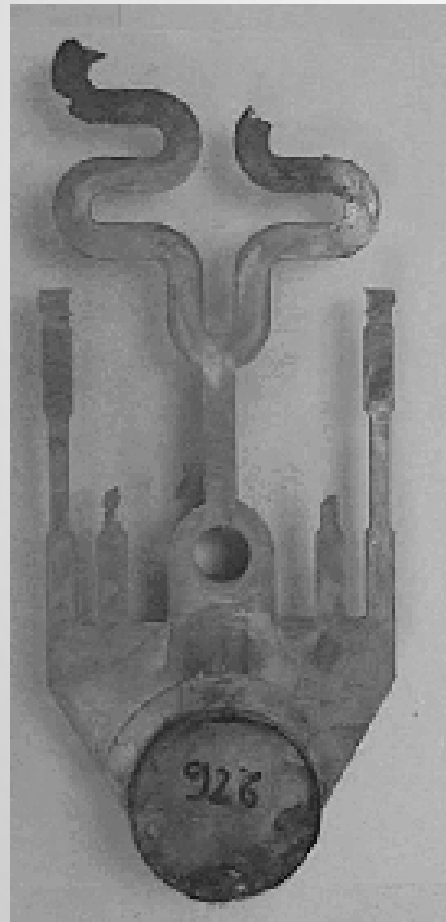
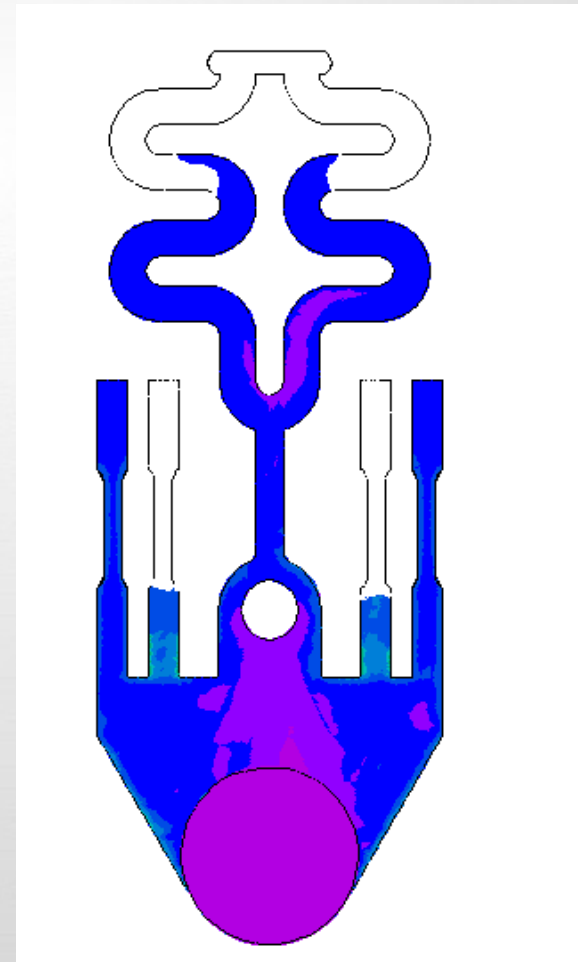
Filling (*Procast*)

Thixocasting validation

Sophia Antipolis, Collot

Magnesium alloy (AZ91):

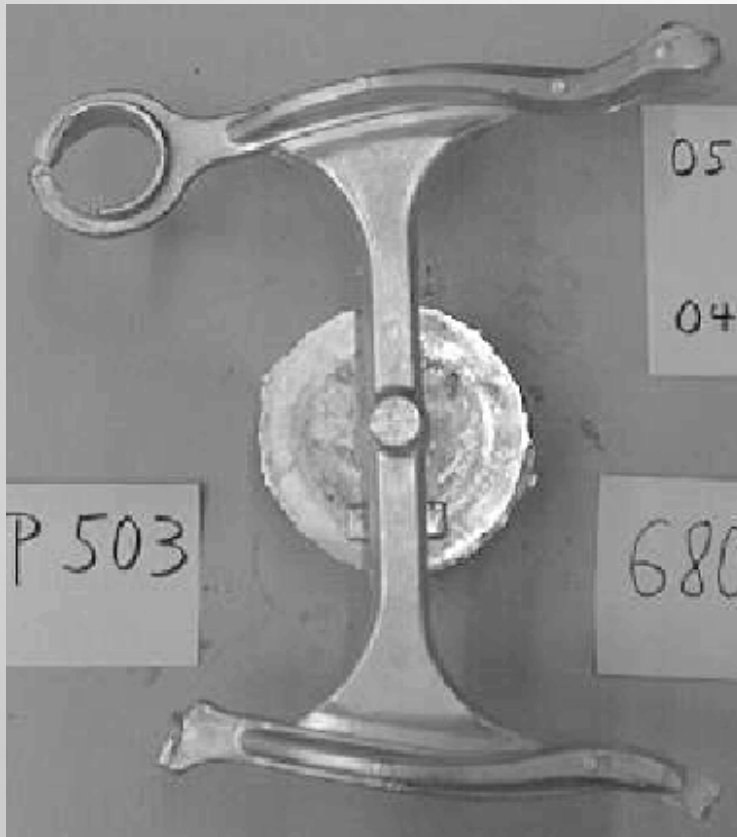
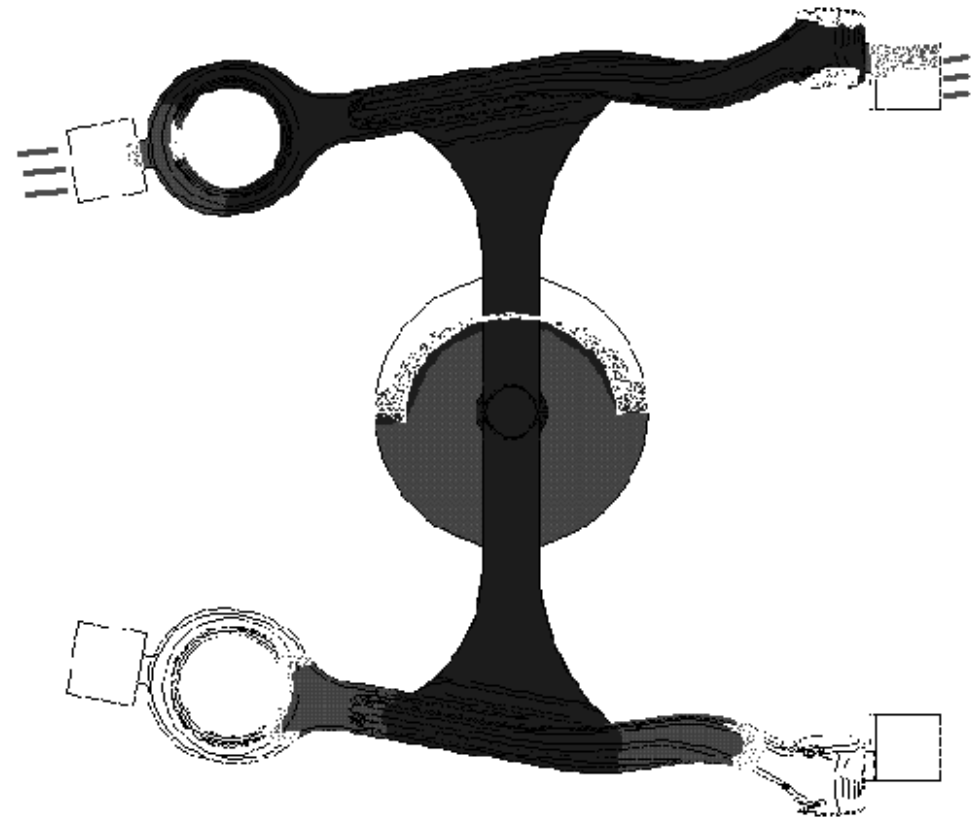
Filling (*Procast*)

Thixocasting validation

Courtesy of Alusuisse

Aluminium alloy (A356)

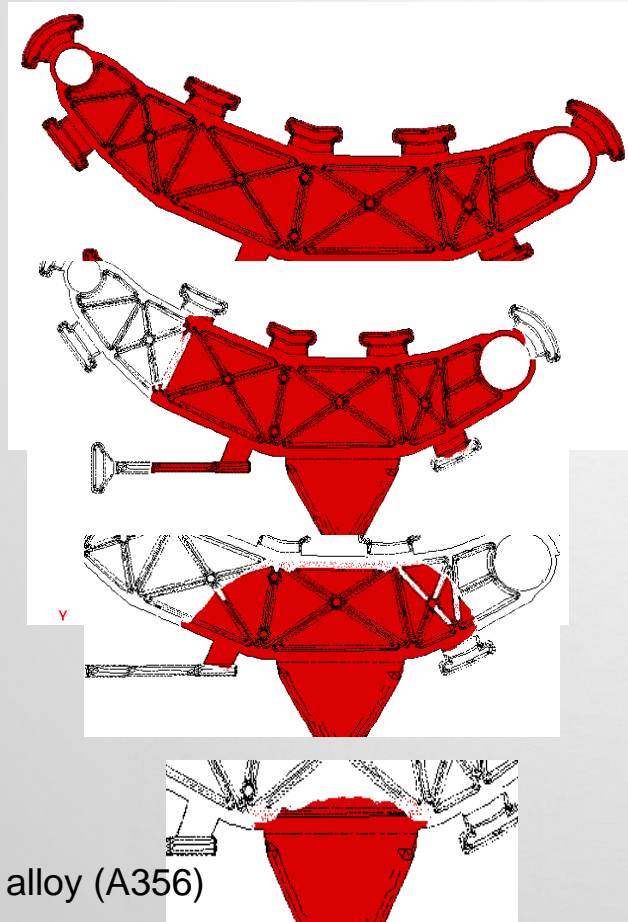
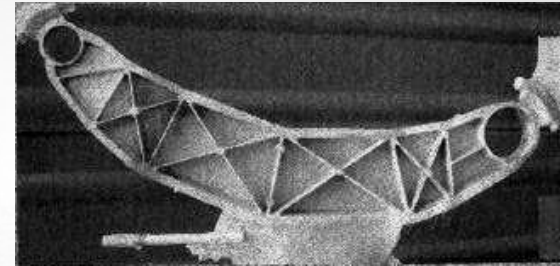
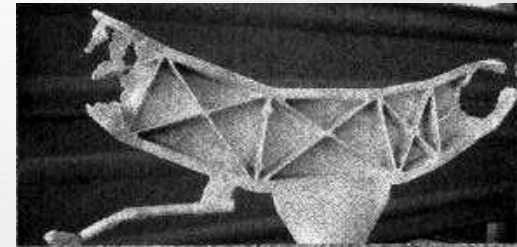
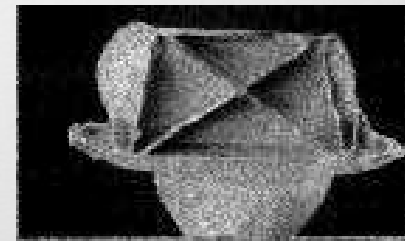
Filling (*Procast*)

Thixocasting validation

Aluminium alloy (A356)

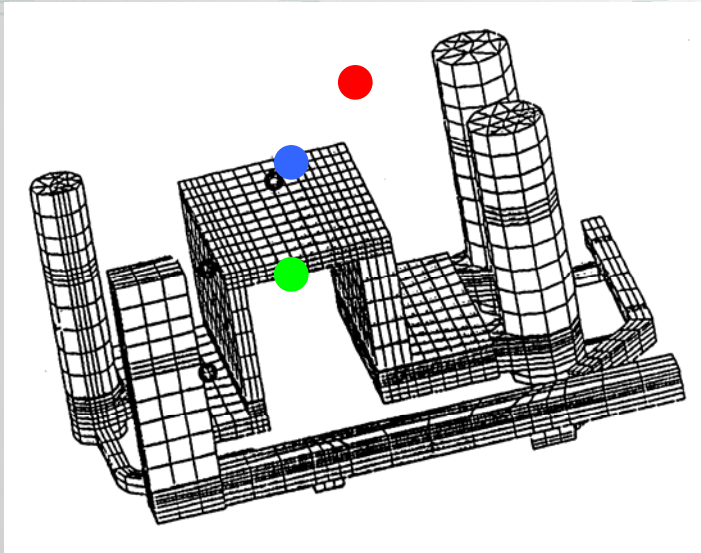
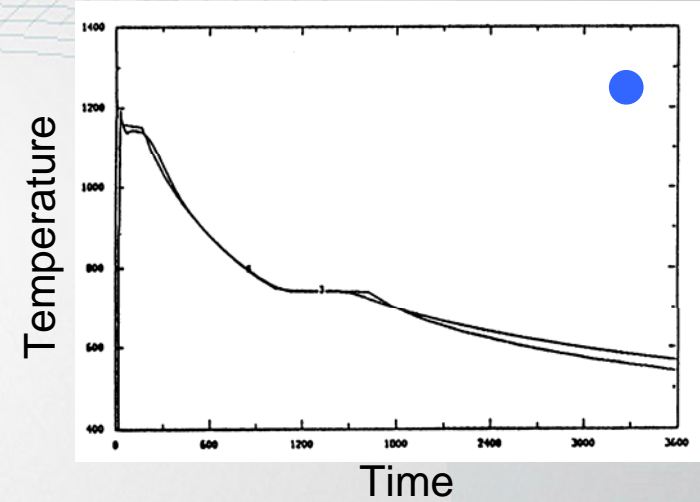
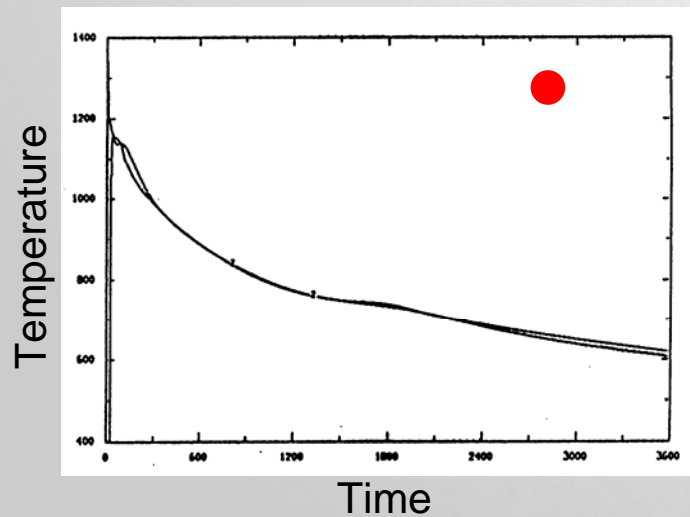
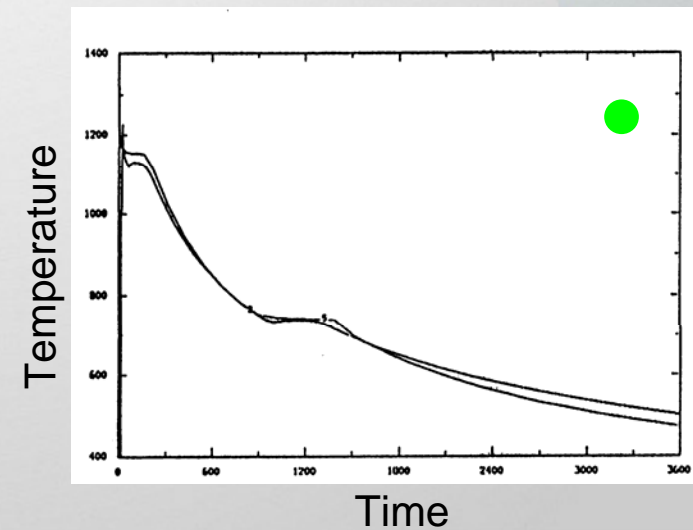
Thermal (*Procast*)

Temperature validation

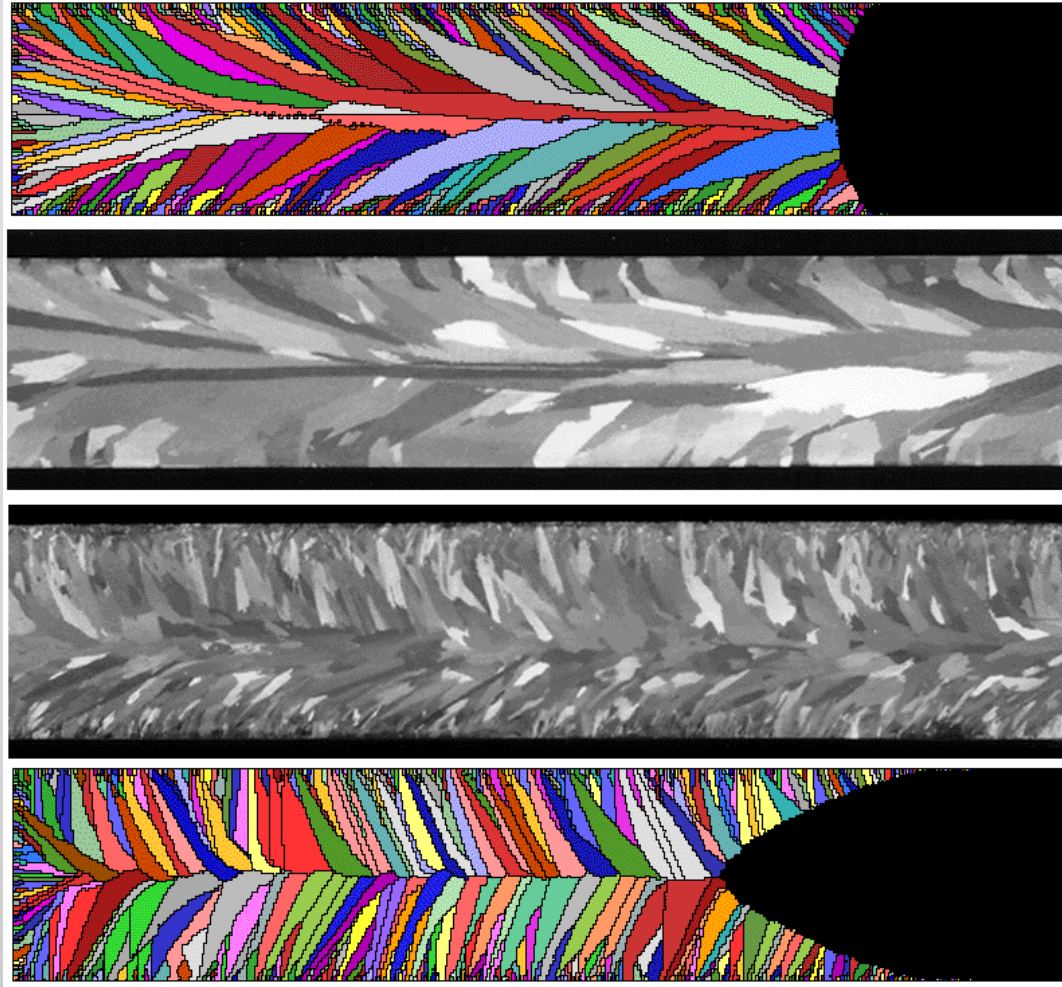
Microstructure (calcosoft)

Microstructure validation

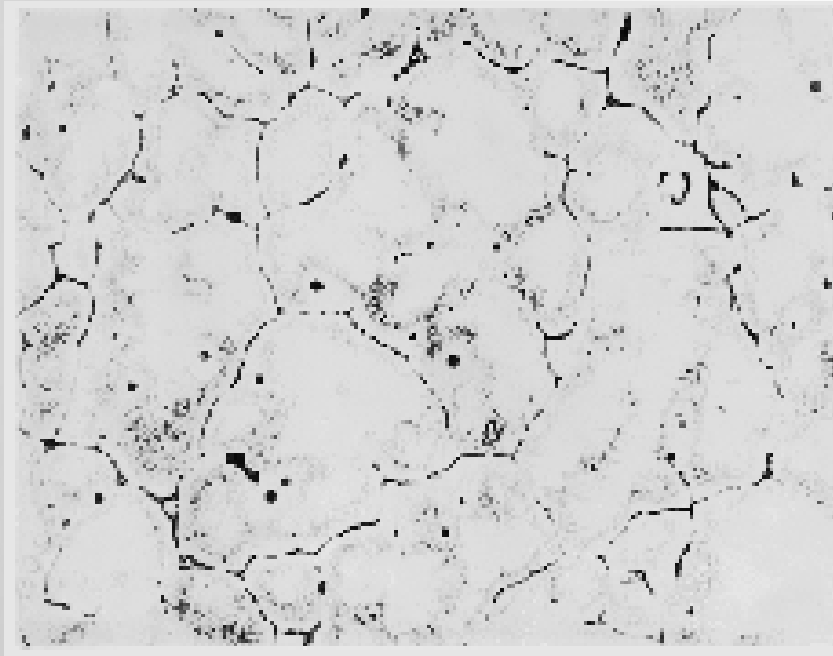
EMPACT Project (DC)

AL-Mg-Si

Experimental microstructure map

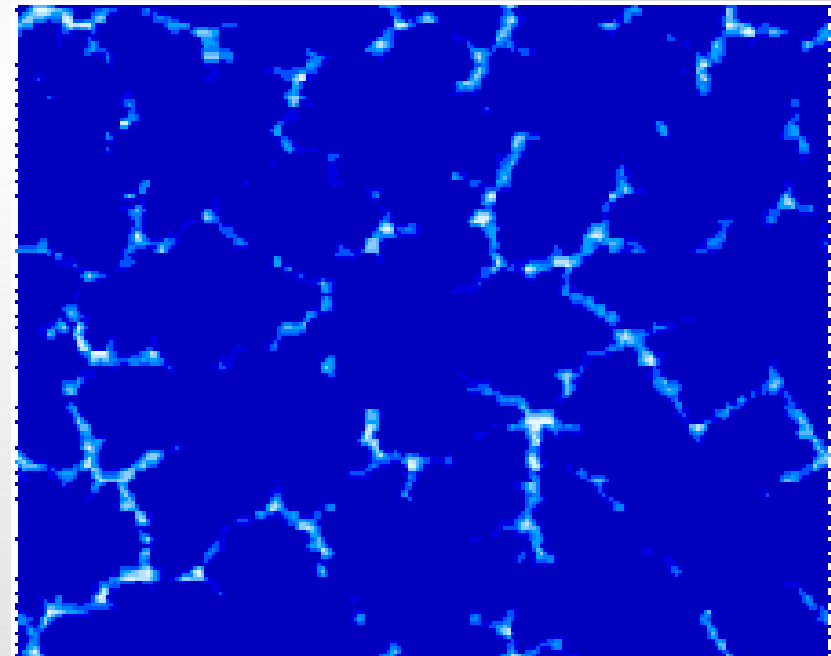
Calculated volume fraction

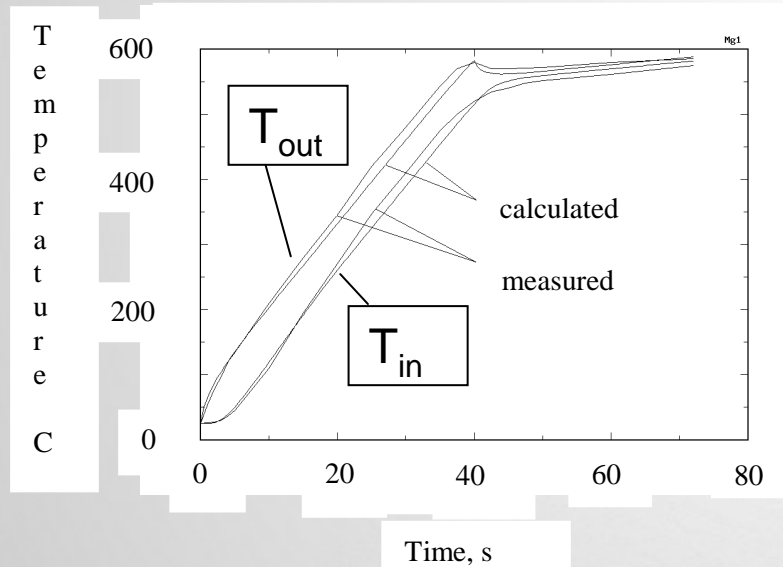
Induction Heating (calcosoft 2D)

Temperature validation

First ramp: 97V, 40s
Second ramp: 47V 32s
(total heating time 72s)

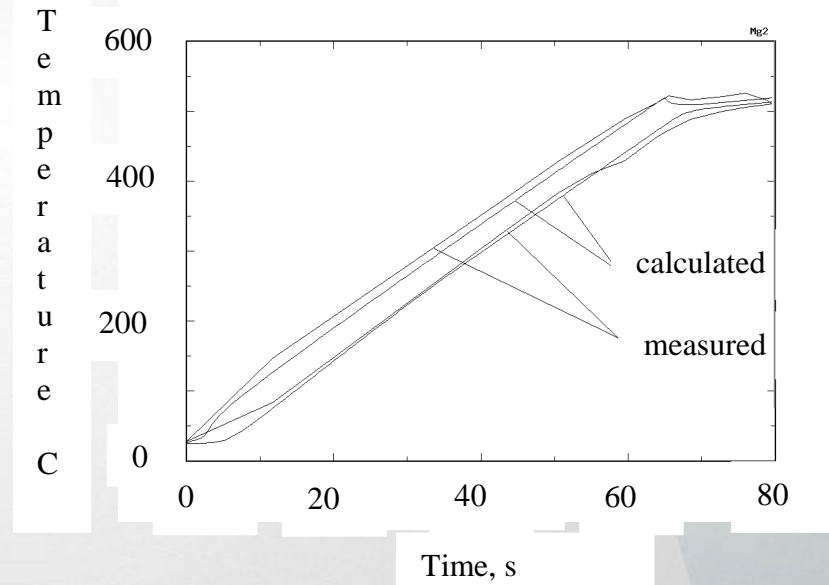
Magnesium feedstock (AZ91)

First ramp : 72V, 65s
Second step: 47V, 15s
(total heating time 80s)

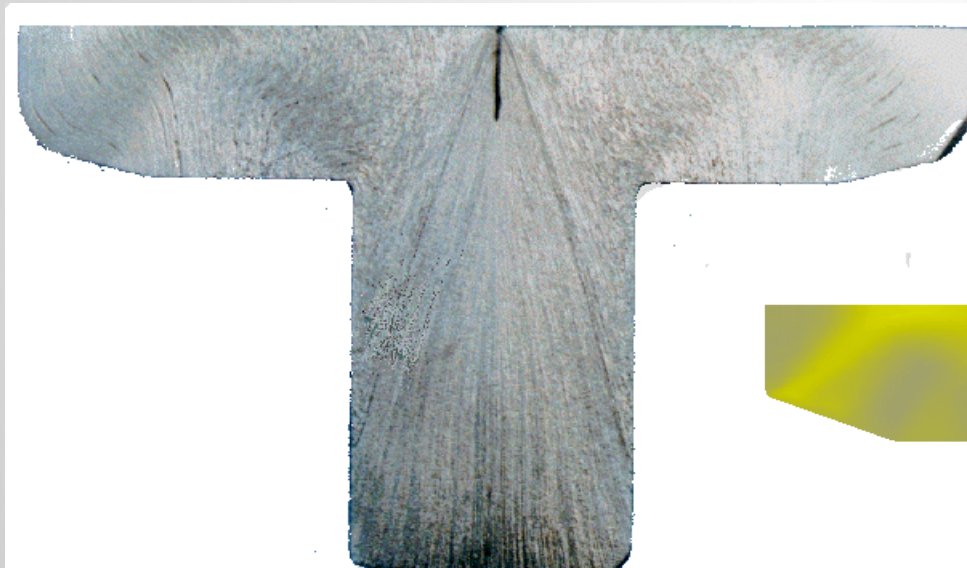
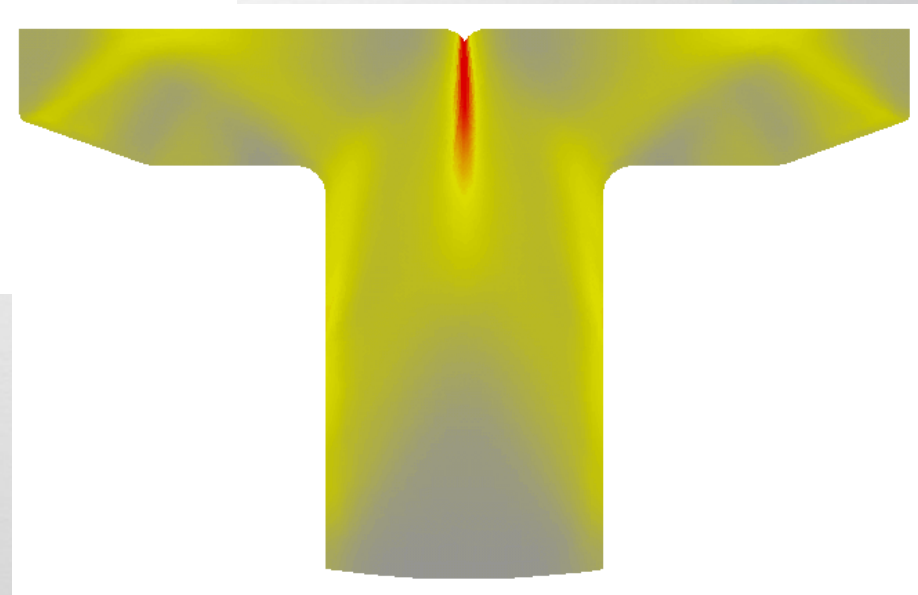
Piping Defect (DEFORM)

- Cold extruded 6062 aluminum pressure valve exhibited a piping defect on the ram/punch contact face

2D metal flow validation

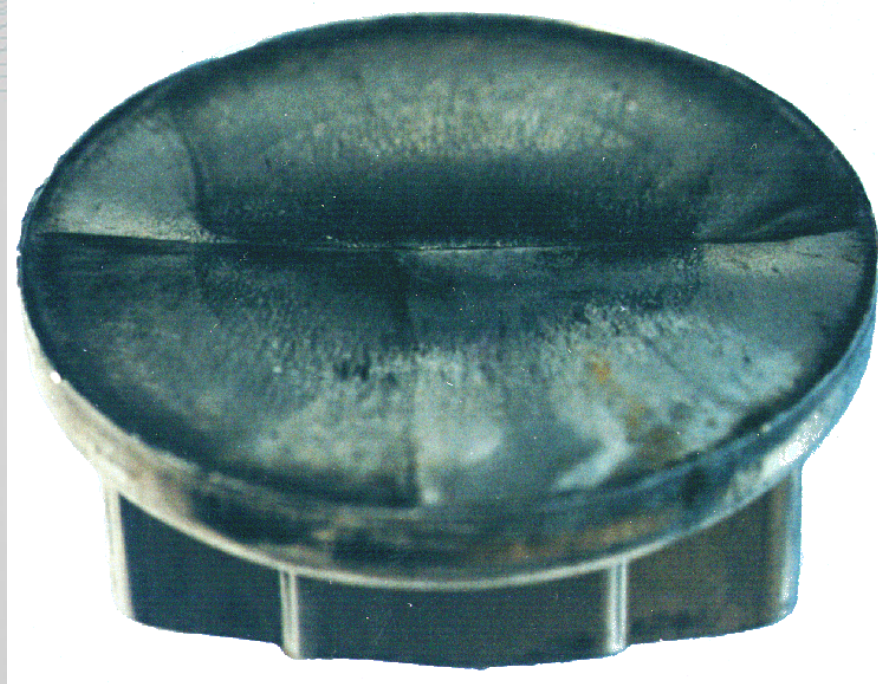
Piping Defect (DEFORM)

3D metal flow validation

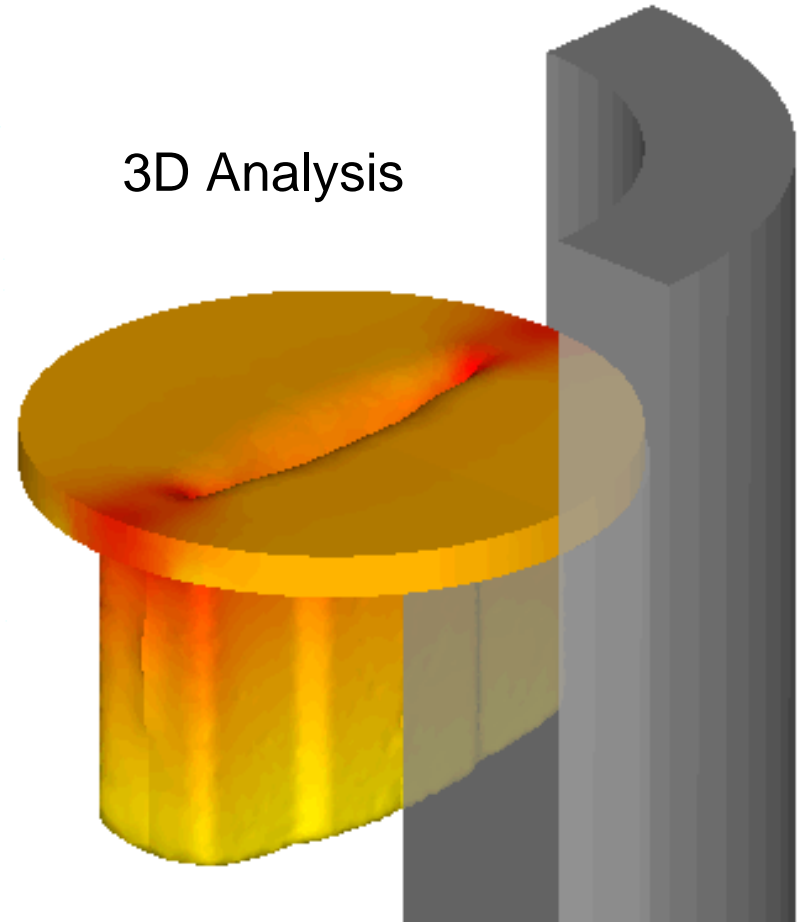
3D Analysis

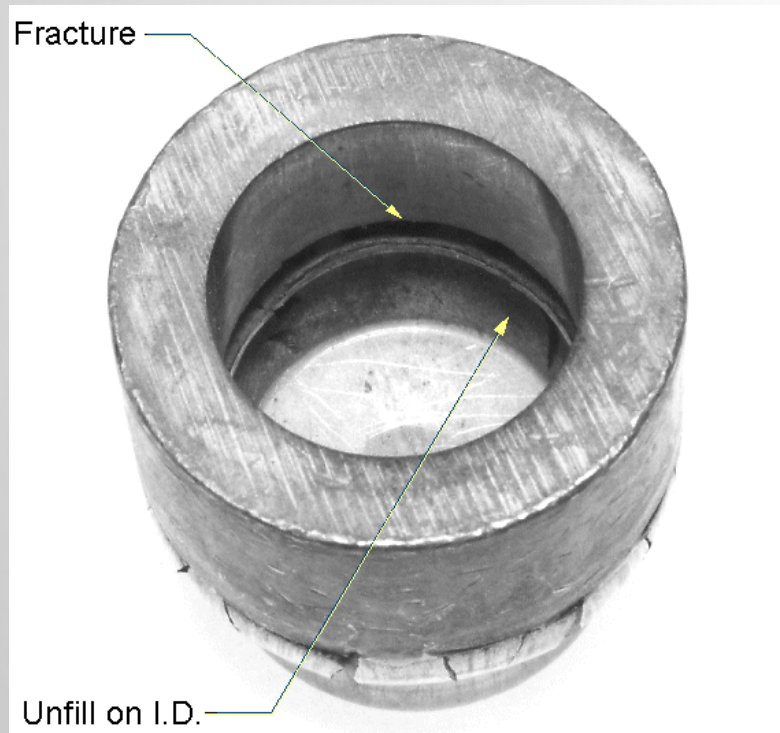
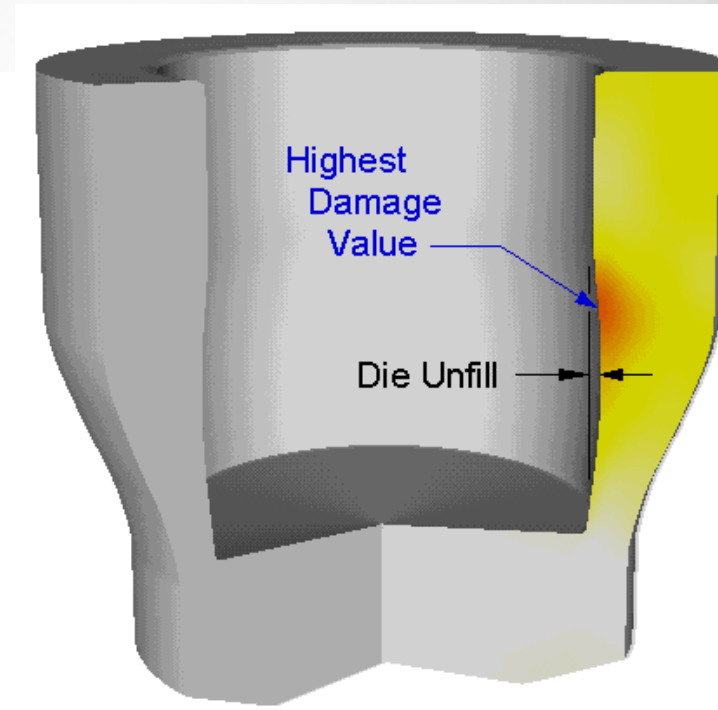
Fracture and Die Unfill (DEFORM)

- Reverse extrusion component experienced severe fracture during an initial die tryout

2D metal flow and fracture validation

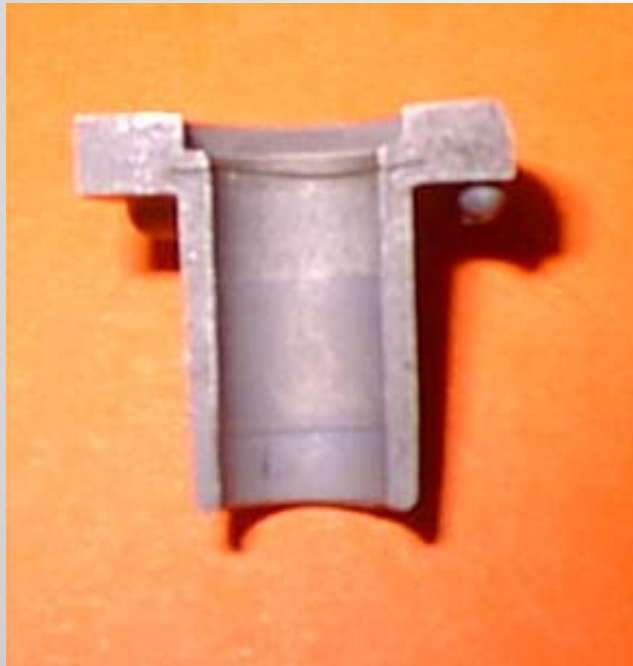
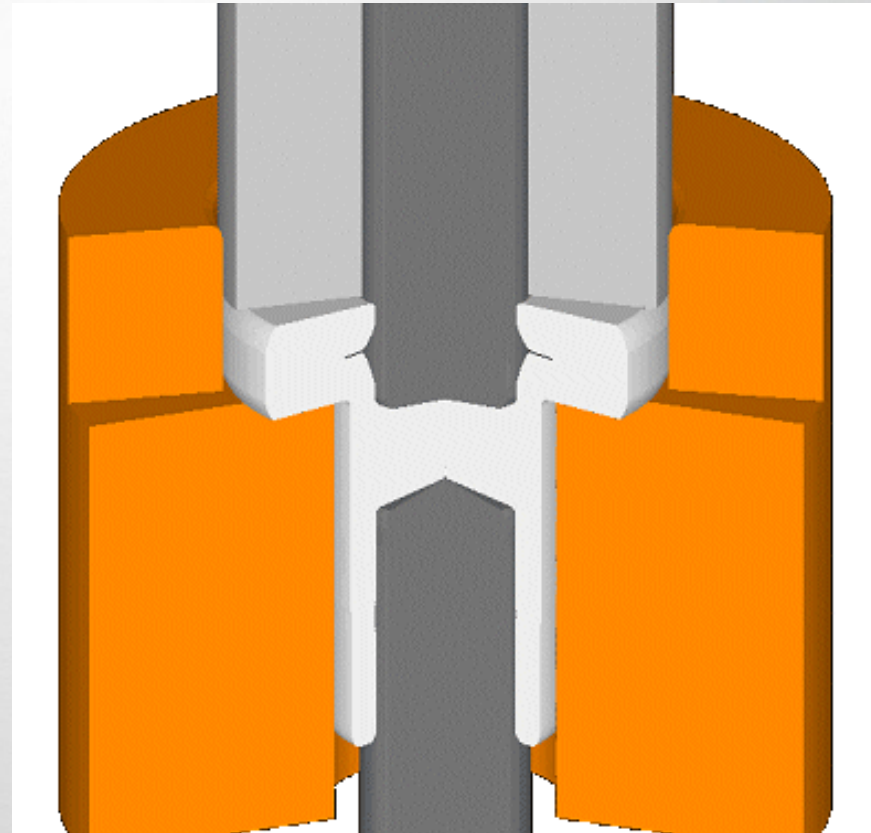
Lap Defect (DEFORM)

- Cold headed fastener progression experiencing a surface lap defect

2D metal flow validation

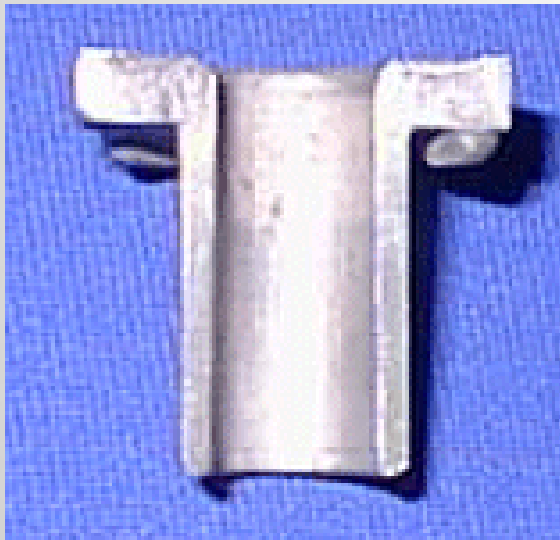
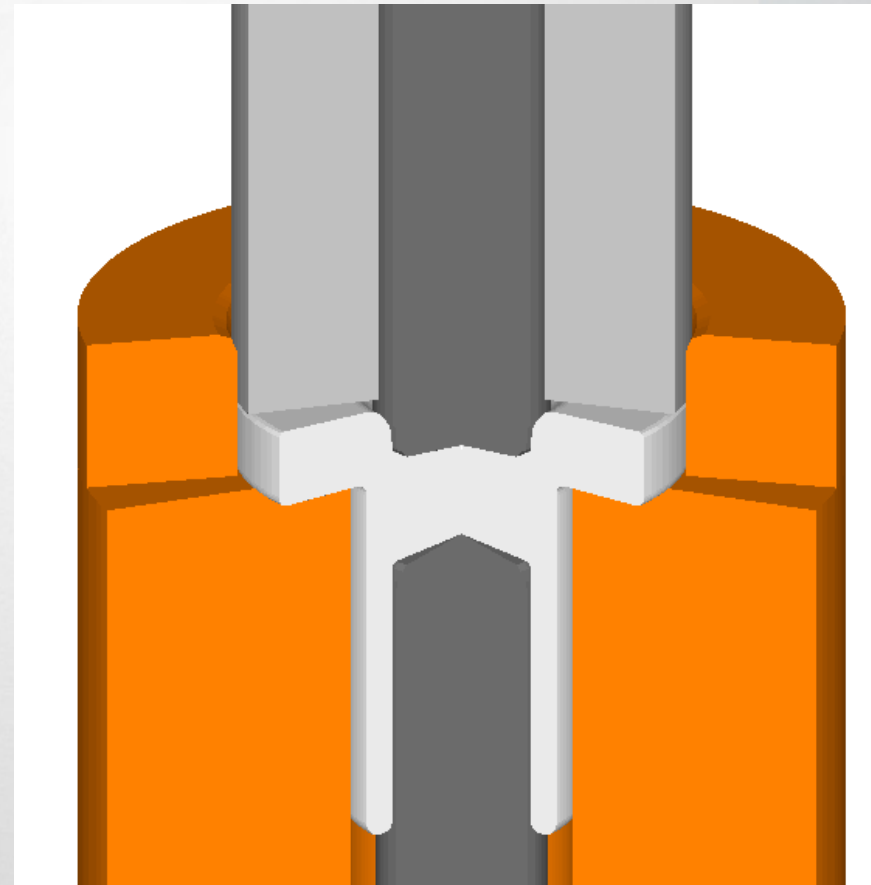
Lap Defect (DEFORM)

2D metal flow validation

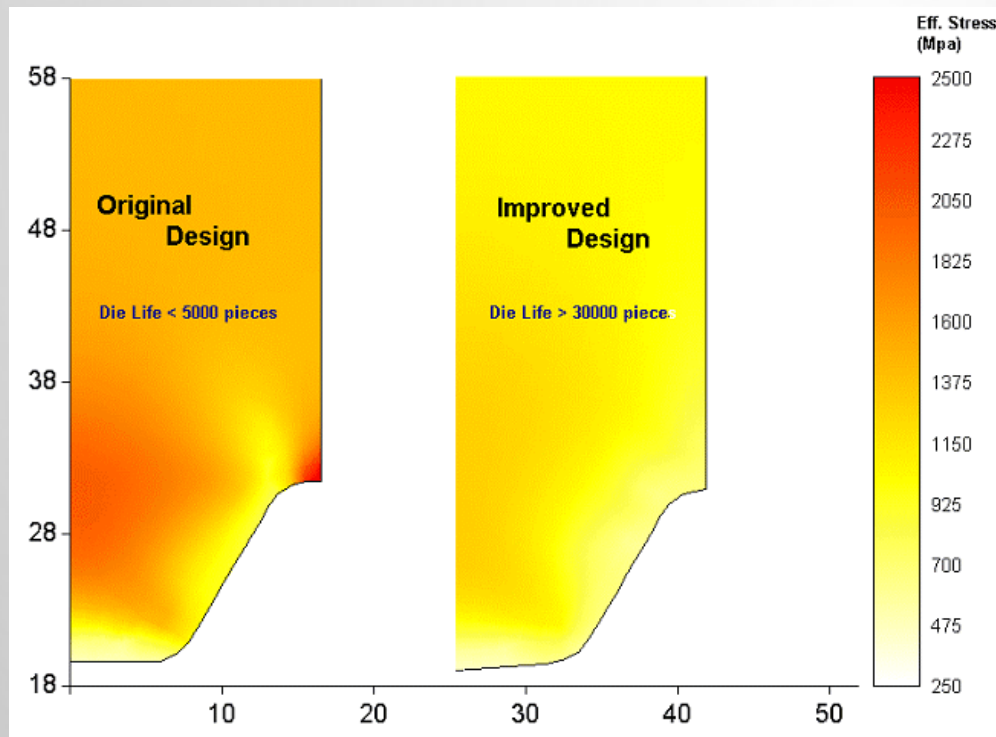
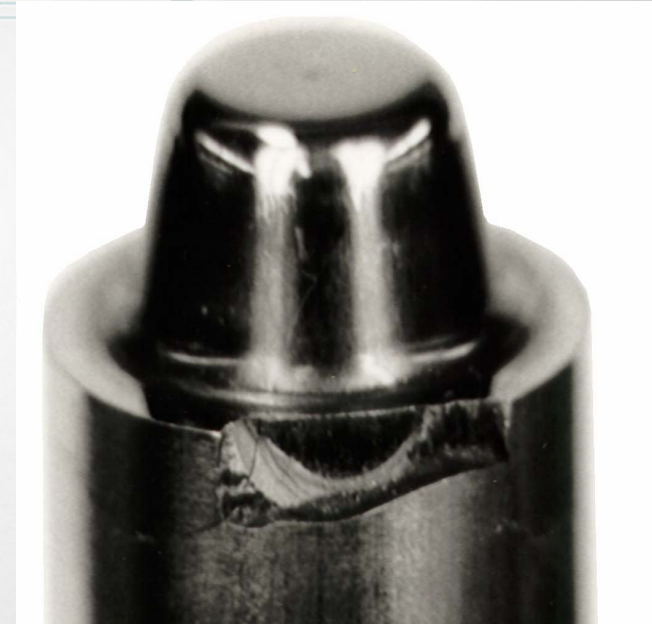
Punch Fracture (DEFORM)

- ◆ Warm forming gear blank.
- ◆ Low cycle fatigue (LCF).

Fracture validation

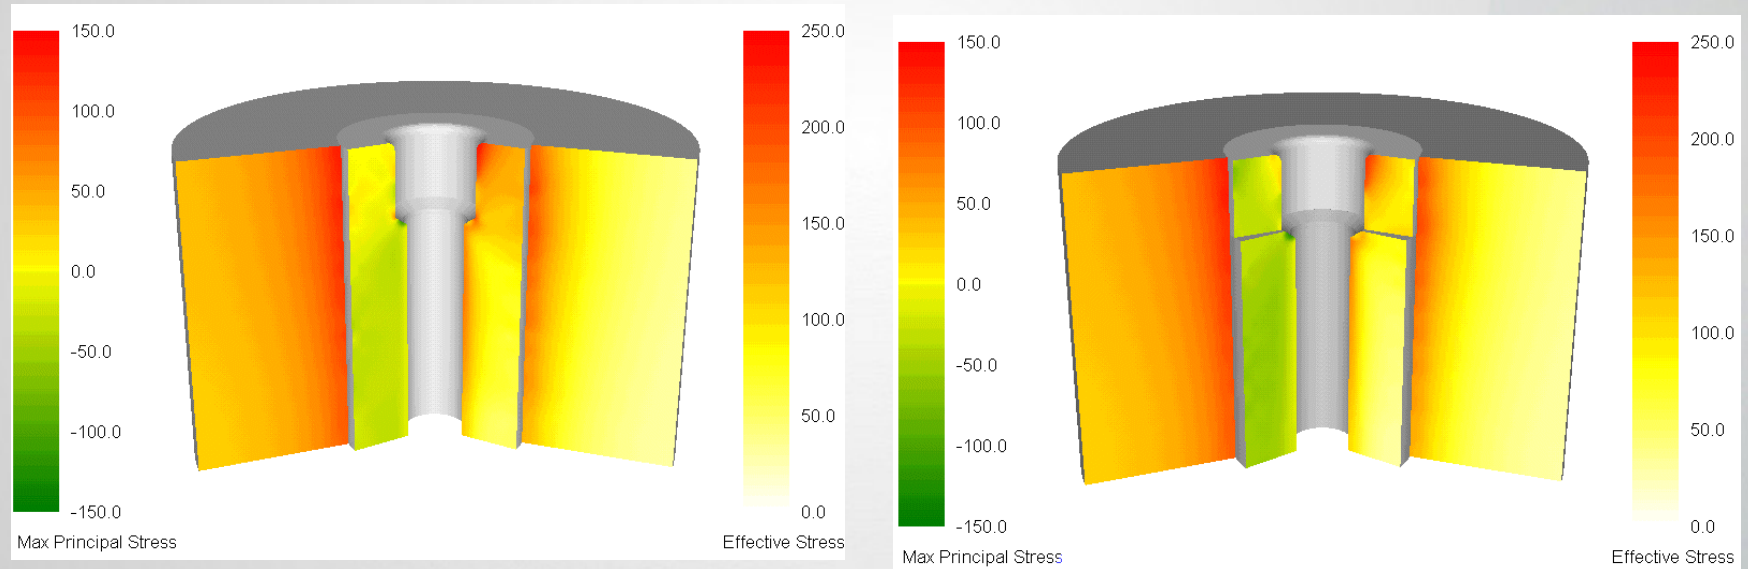
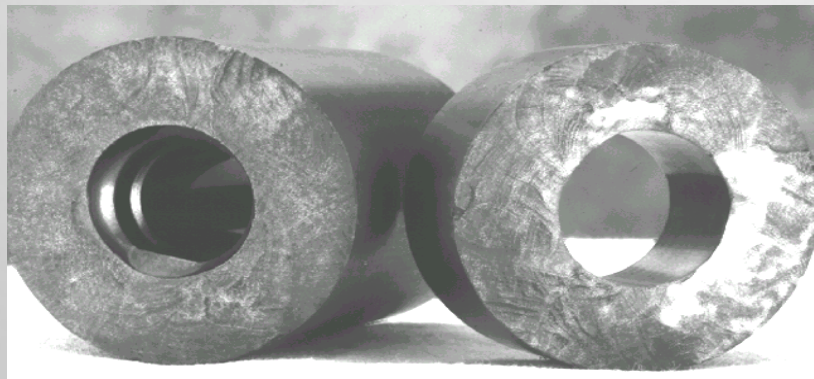
Die Insert Fracture (DEFORM)

- ◆ Die (insert) failure of a cold formed automotive part.

Fracture validation
